**Safety Standards and Inspection Techniques  
For Natural Gas Composite Cylinders**

Craig Webster  
Powertech Labs Inc.

September 1999

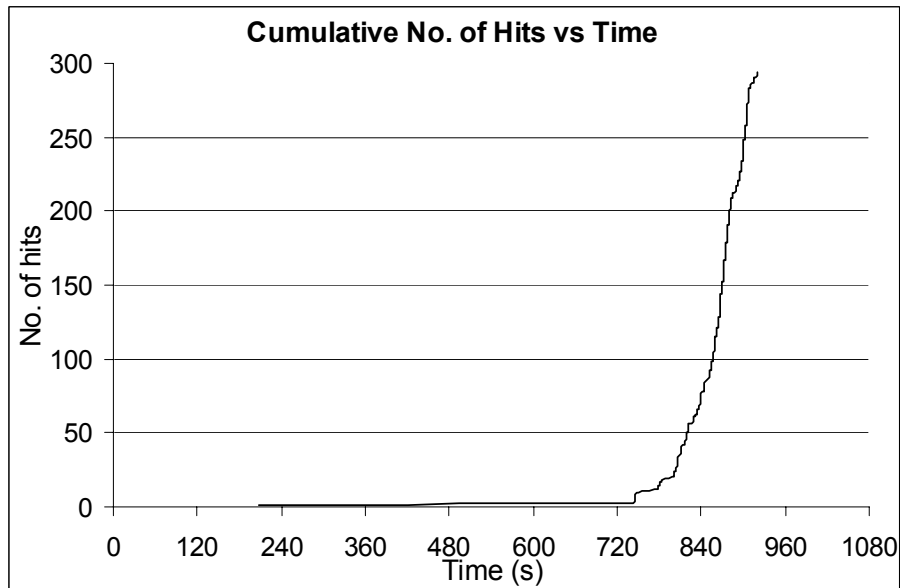
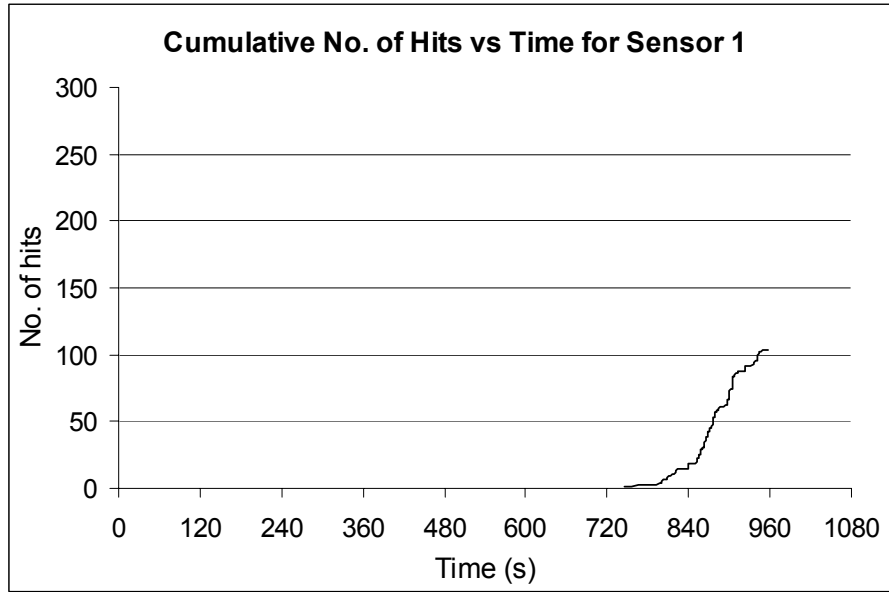
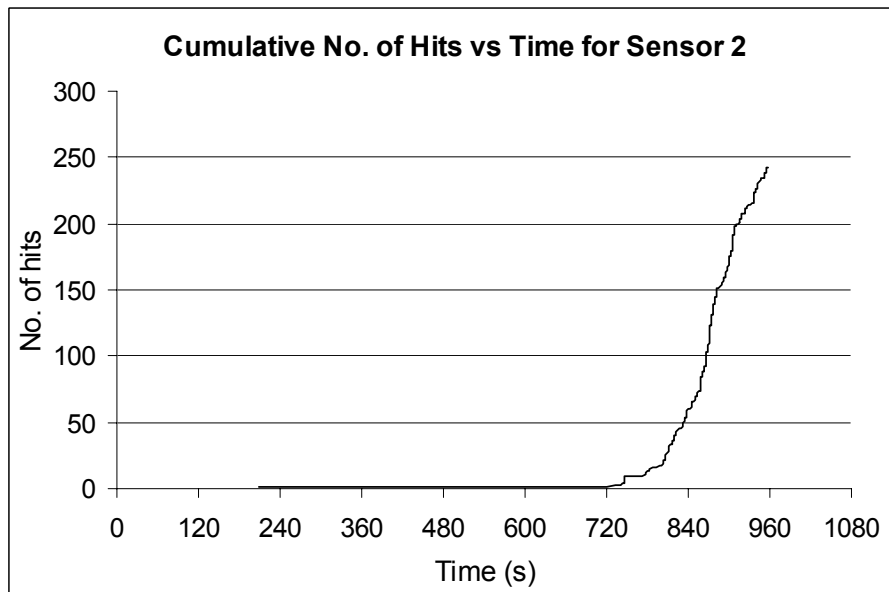
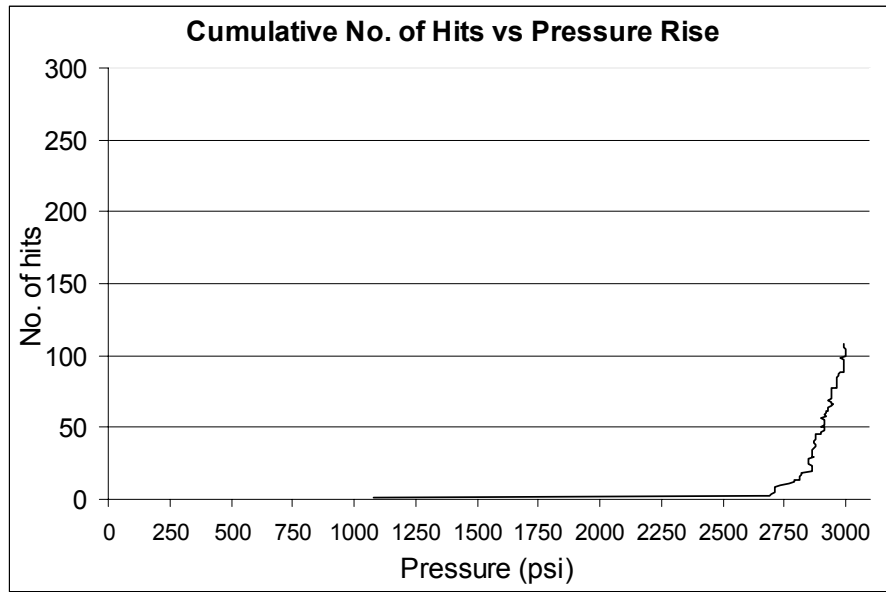
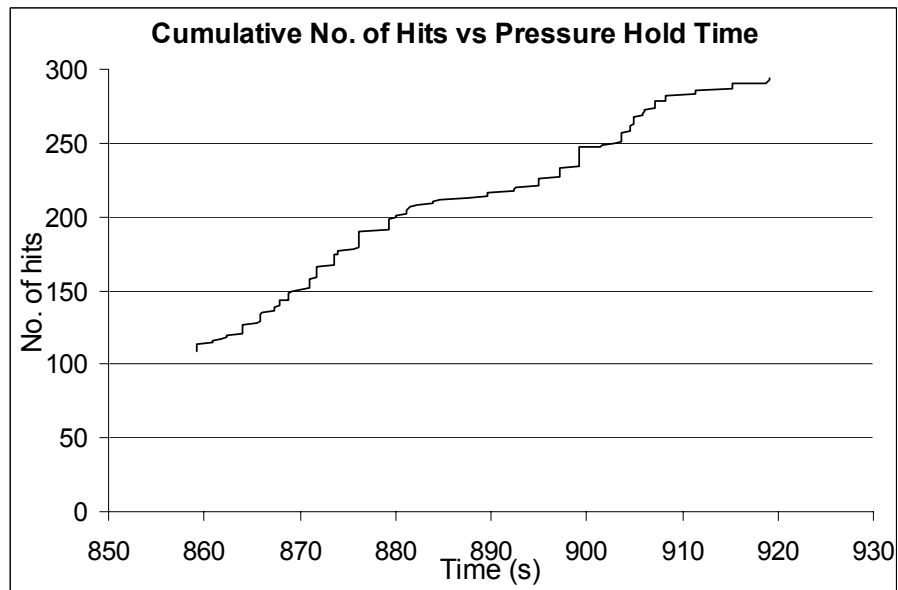
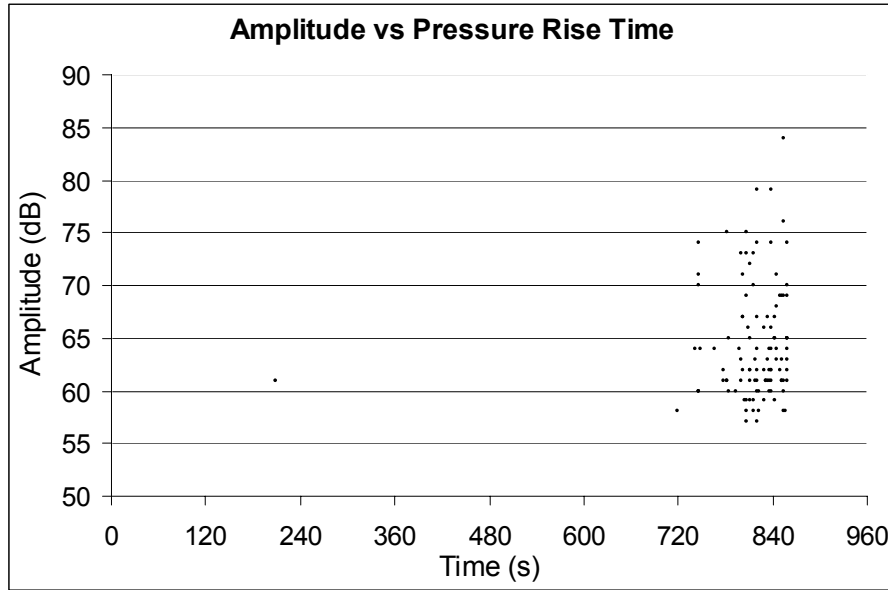
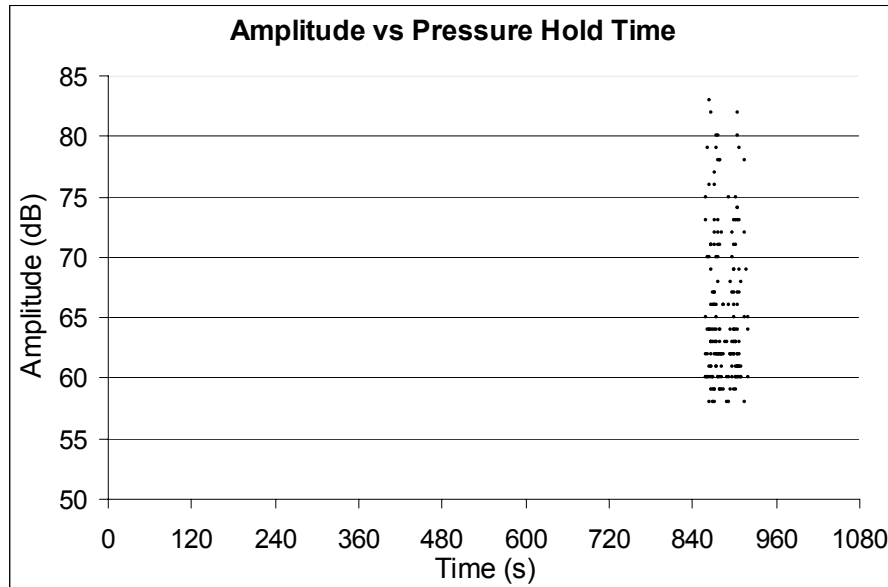
The test shows that the acoustic emissions recorded correspond to an undamaged cylinder. Activity starts over 180 bar (1800 psi), and the felicity ratio is good: 0.9. The amplitudes recorded remain under 90 dB, which shows that there are no major events.

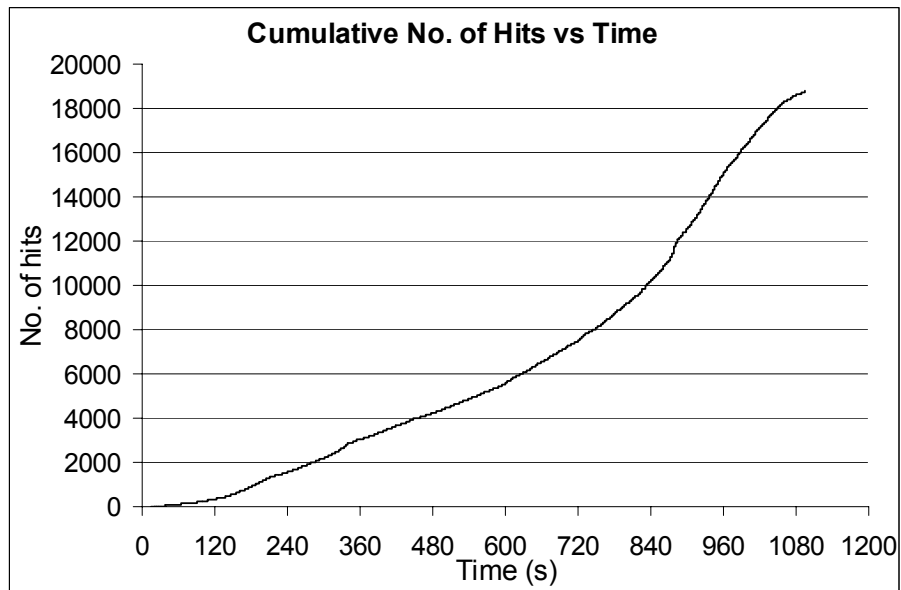
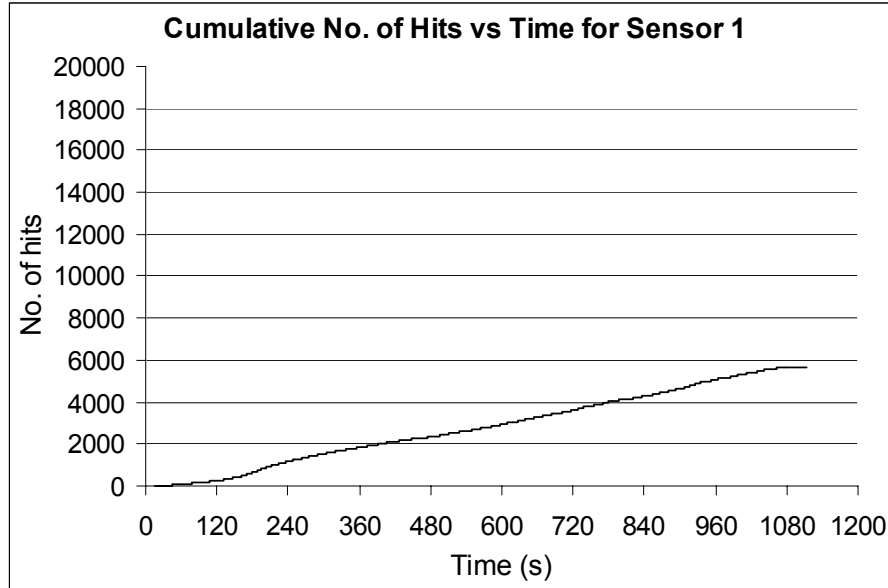
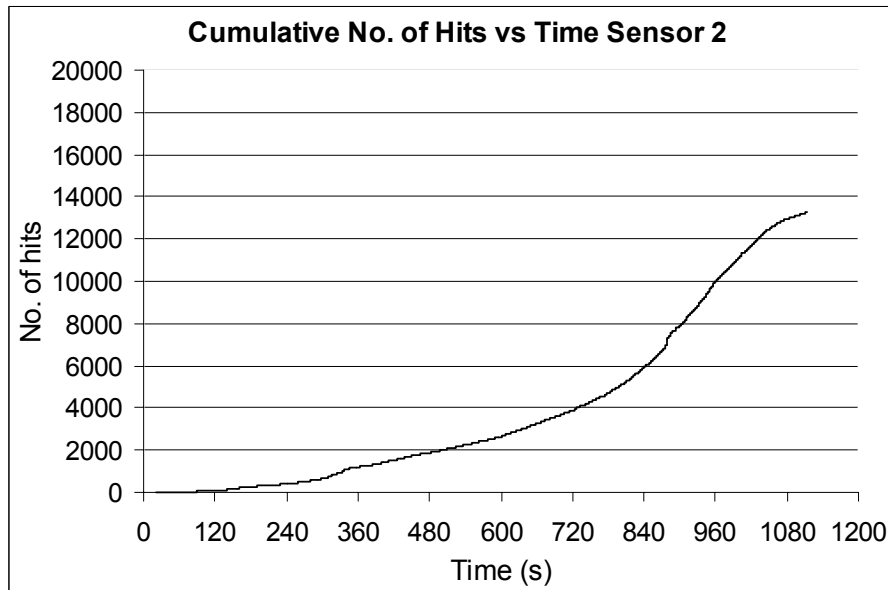
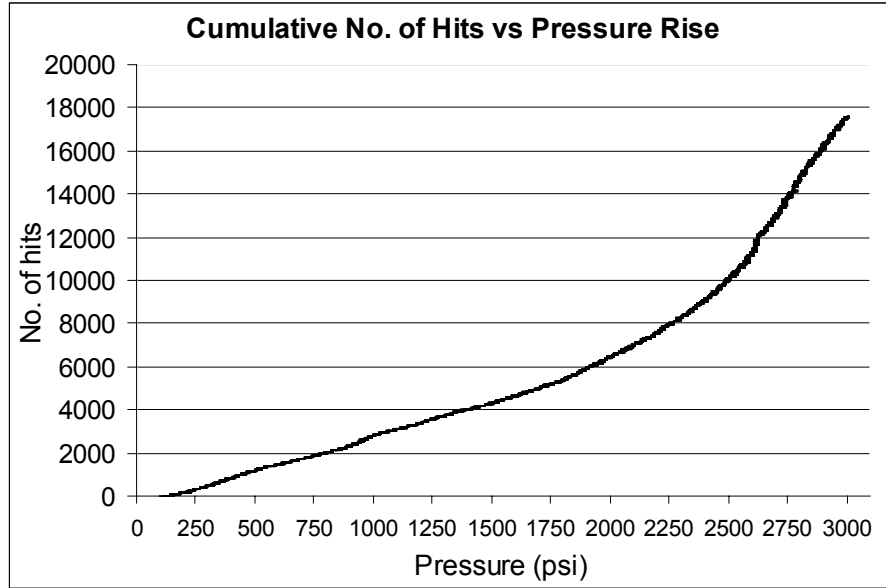
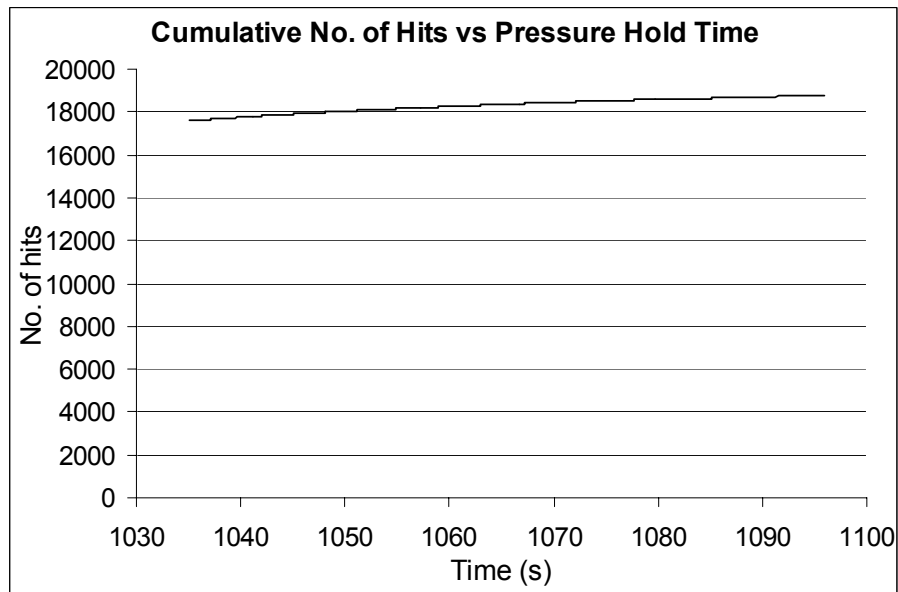
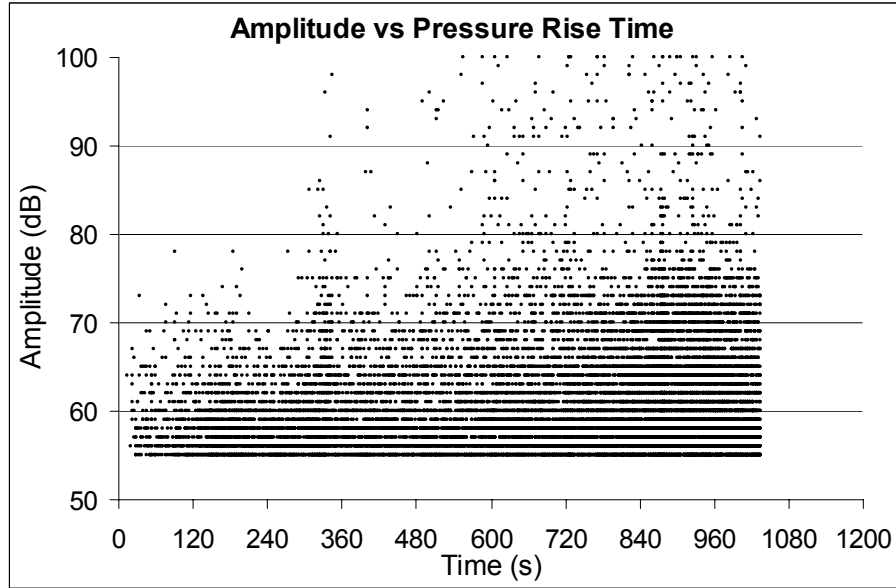
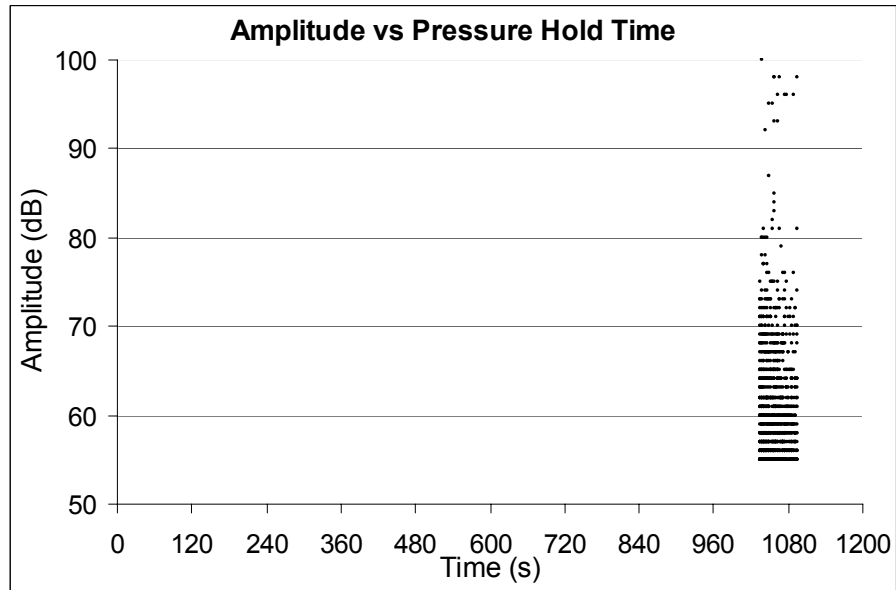
We can see that the number of hits recorded by the second sensor is considerably bigger than the one of the first sensor. This would correspond with the importance of the damages to the structure. The test results clearly show that the cylinder is damaged. The first hits appear at very low pressure, and their amplitude become very high (84 dB) at pressures as low as 68 bar (990 psi). The global number of hits is very important in comparison with a non-damaged cylinder, and the felicity ratio dropped to 0.33.

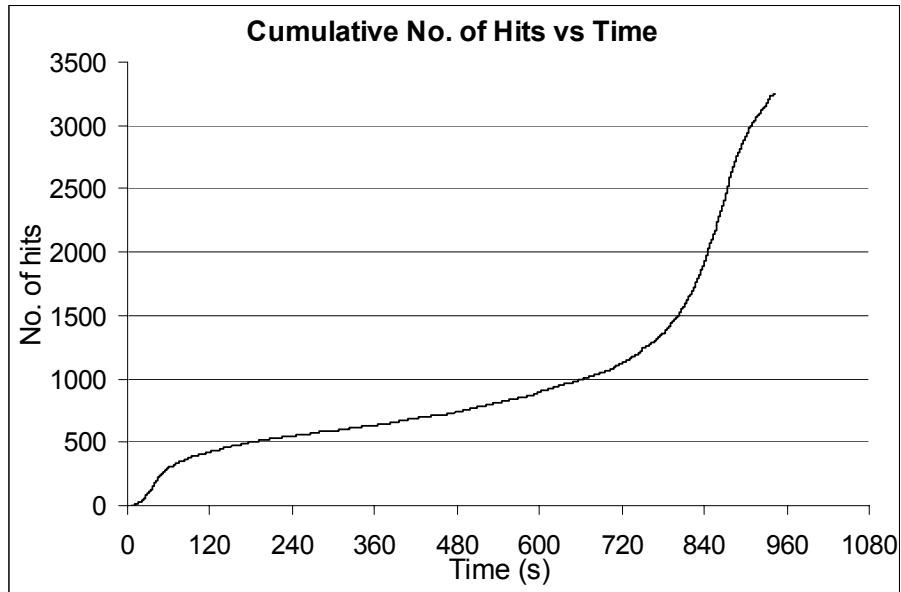
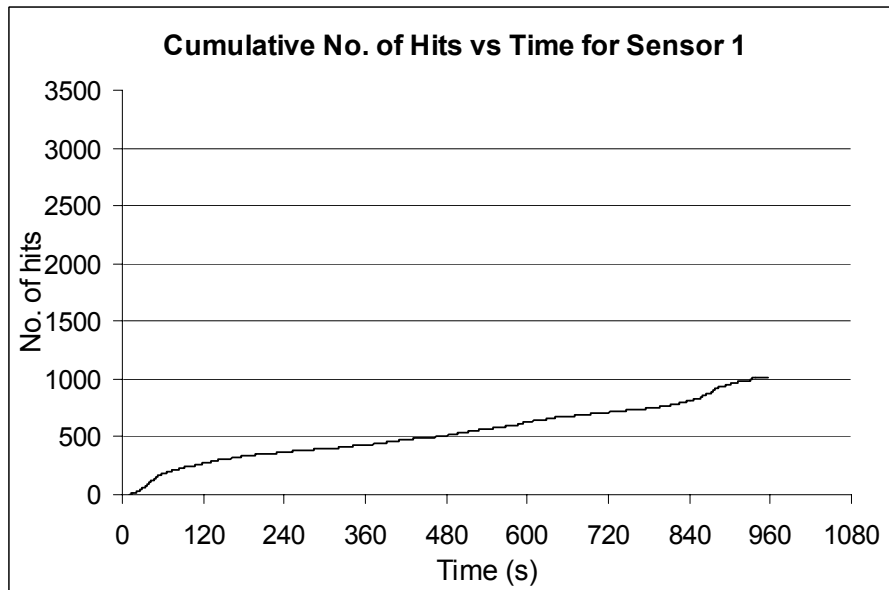
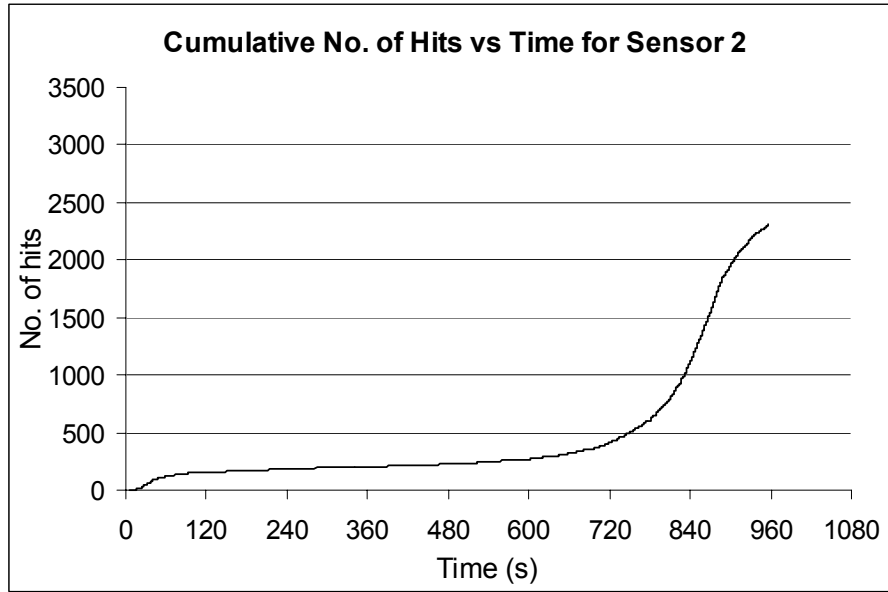
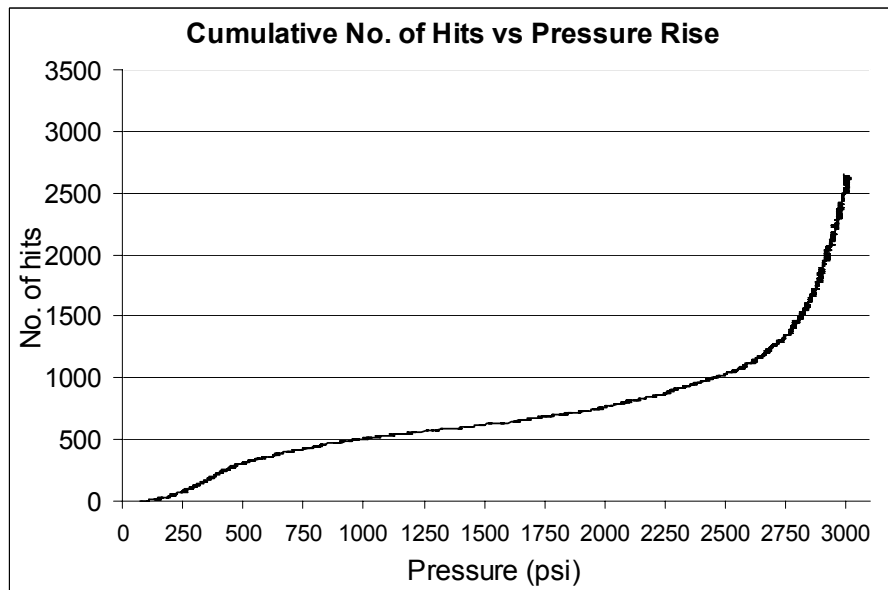
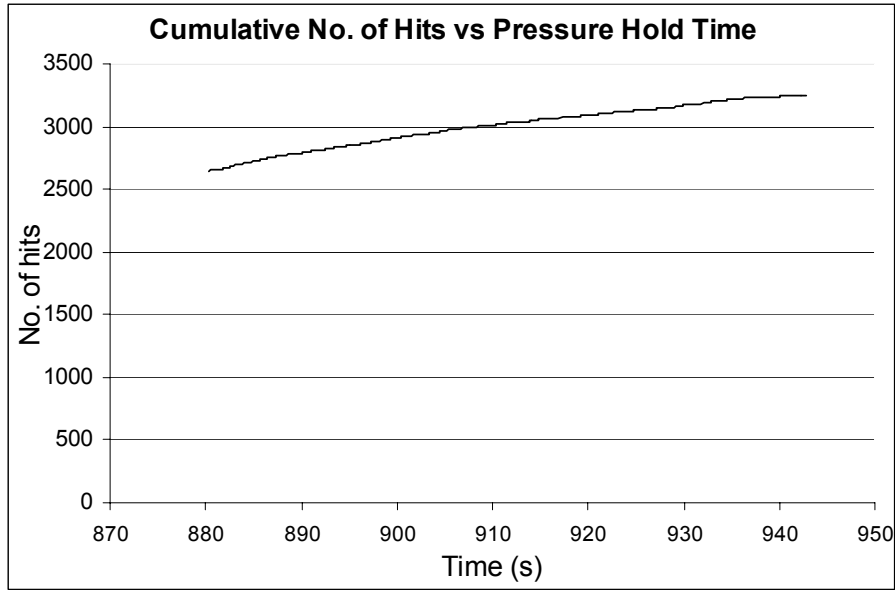
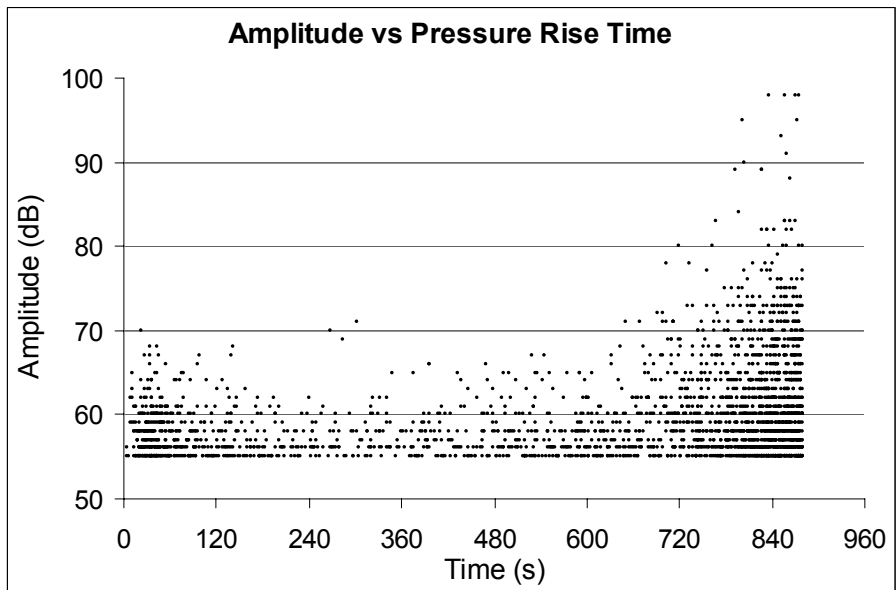
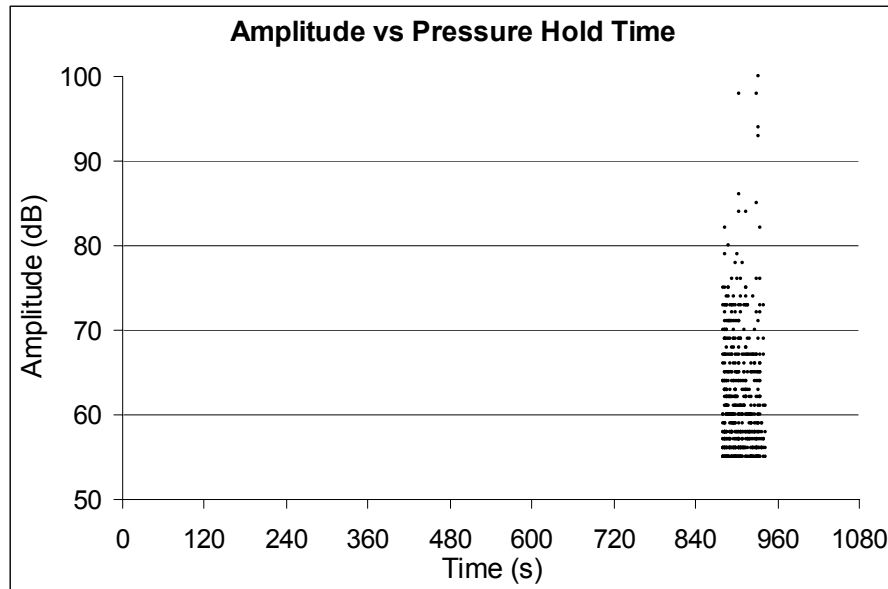
The results show that the general number of hits diminished a lot. Nevertheless, the trend remains characteristic of a damaged cylinder, with a quick rise at the beginning associated with delaminations in the wrapping. The felicity ratio is 0.42, which is still low and indicates the poor mechanical properties of the material.

The examination of the amplitudes reveals that there are fewer event of high amplitude than for the first pressurization. But, several hits with an amplitude higher than 90 dB confirm that the structure is damaged.

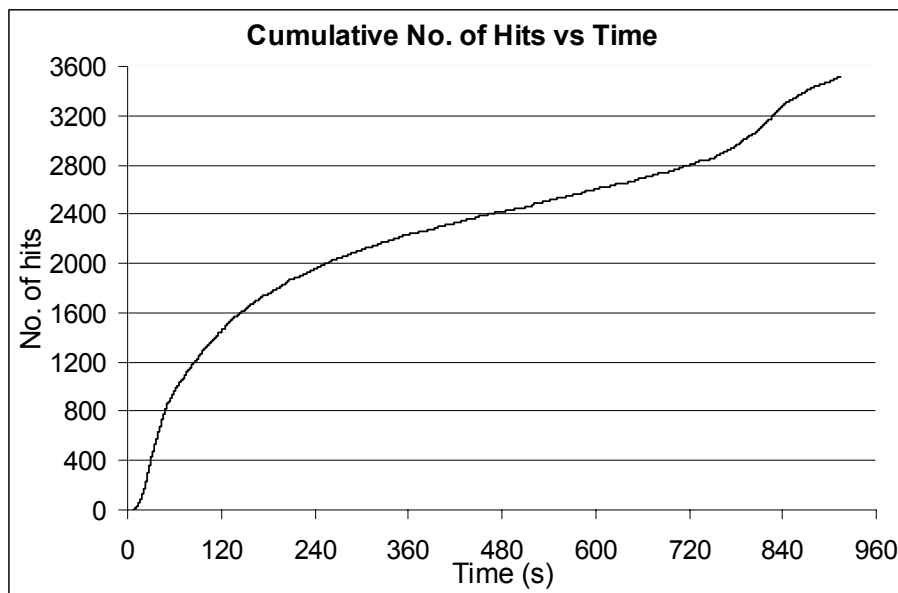
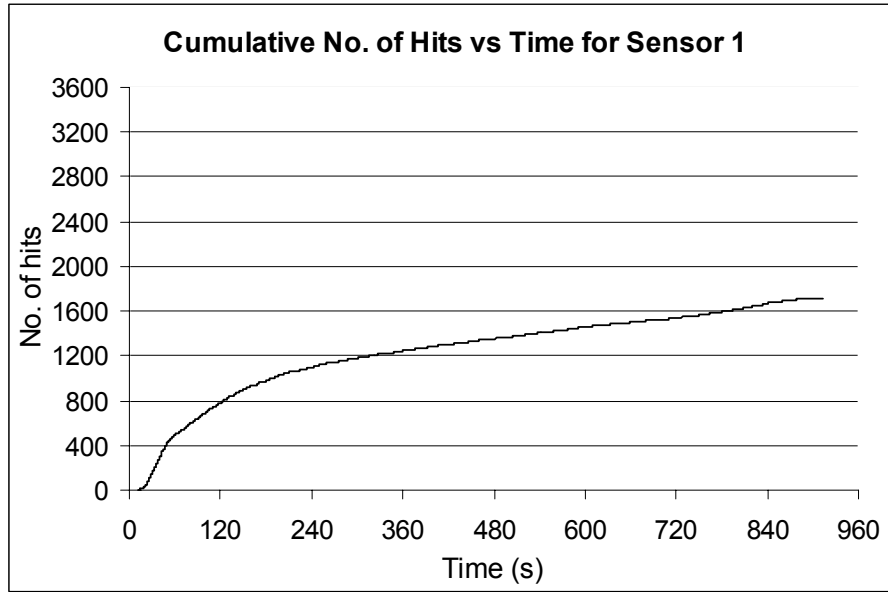
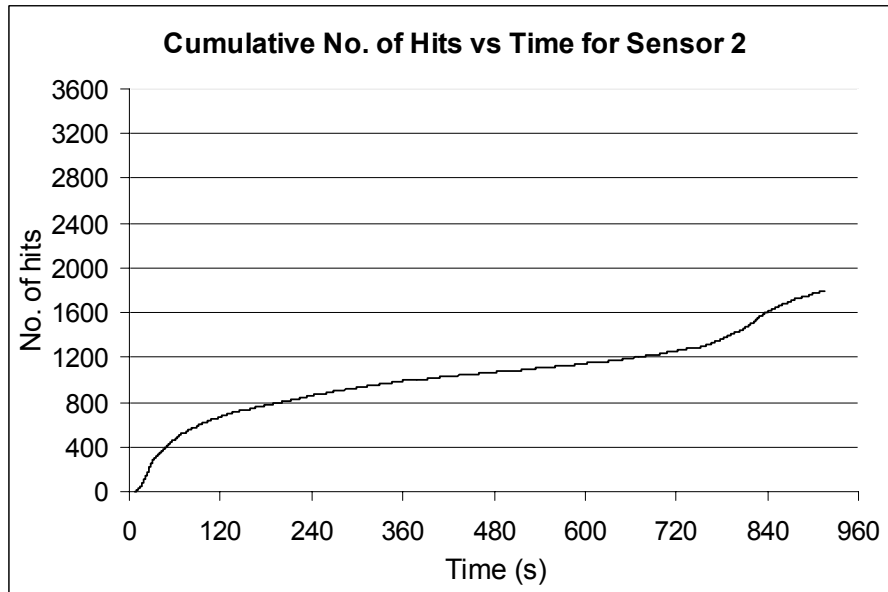
We can still easily detect the damages to the cylinder. The fast increase in the number of hits at low pressure and the number of hits are characteristic. The value of the felicity ratio determined is 0.2, which is still very low. The graph of the amplitudes confirms the previous statement, showing the important rubbing noise at the beginning of the pressurization, and few high amplitude events at high pressure.

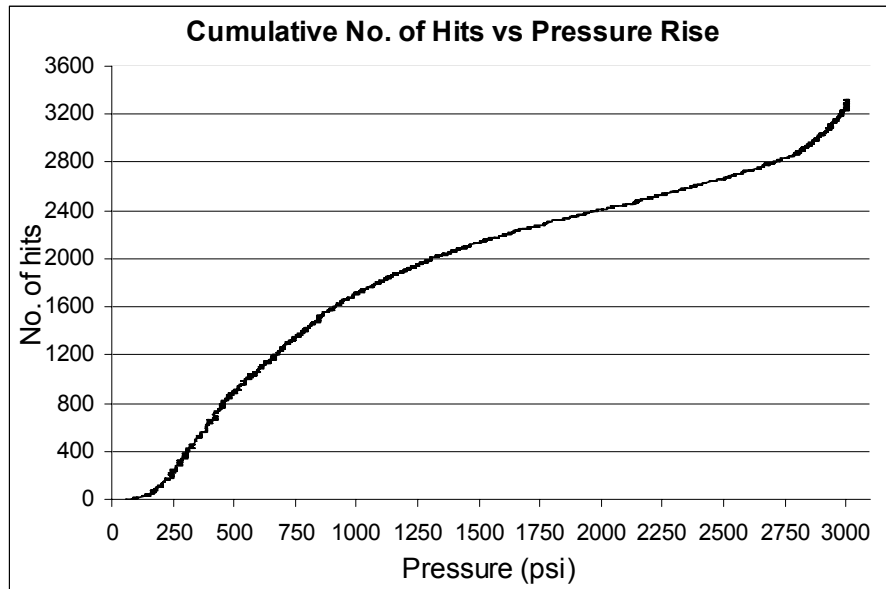
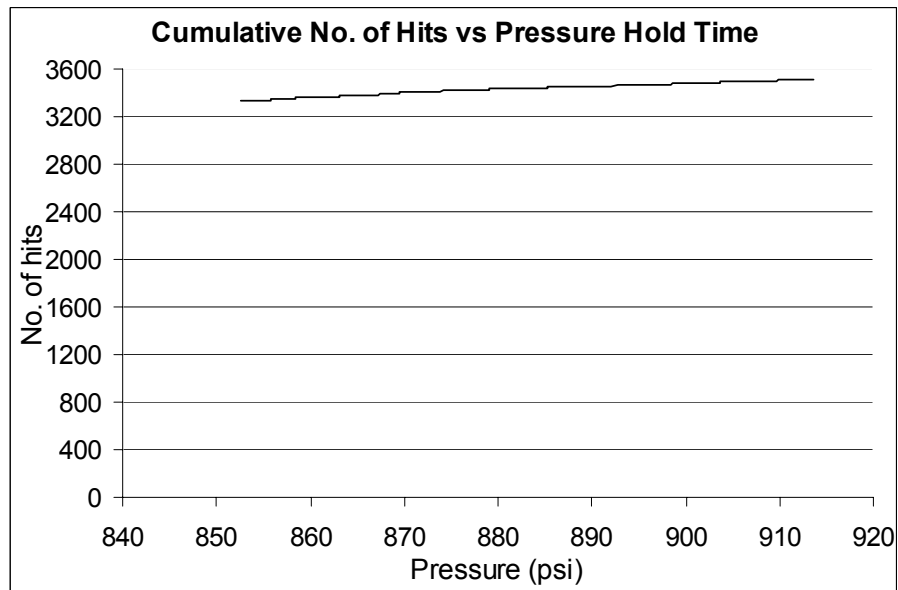
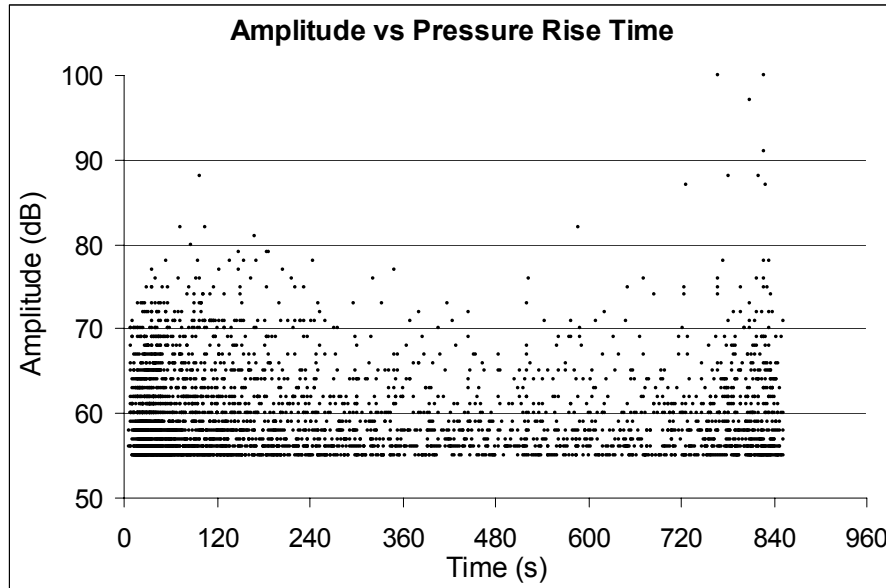
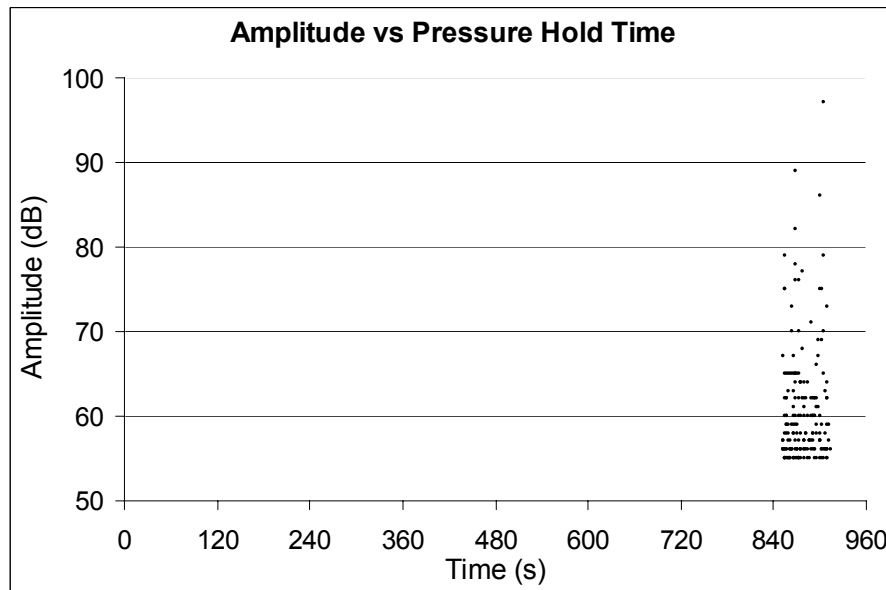
It is interesting to notice that there is a big attenuation of the AE signal between the first pressurization and the other ones. But however strong it is, we are still able to detect the damage to the structure thanks to the shape of the plot, as well as the felicity ratio. Another interesting fact is that the damages are more obvious in the last test than in the second. This means that some further damage occurs during each test, and that the cylinder is more and more likely to fail under stress.

Finally, the cylinder was submitted to a burst test and failed at 328 bar (4757 psi). The failure occurred on the spot of the second impact. The low burst pressure testifies that the cylinder was heavily damaged.

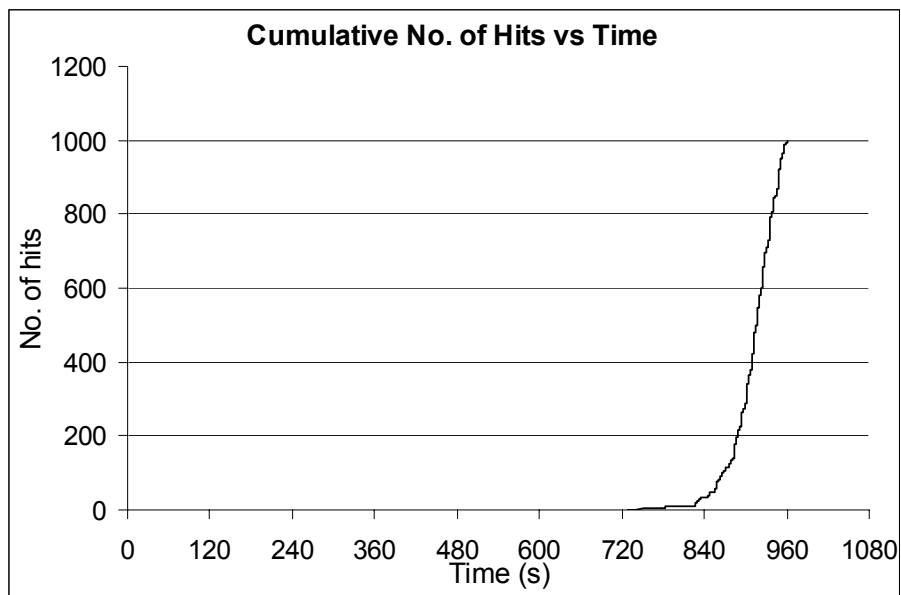
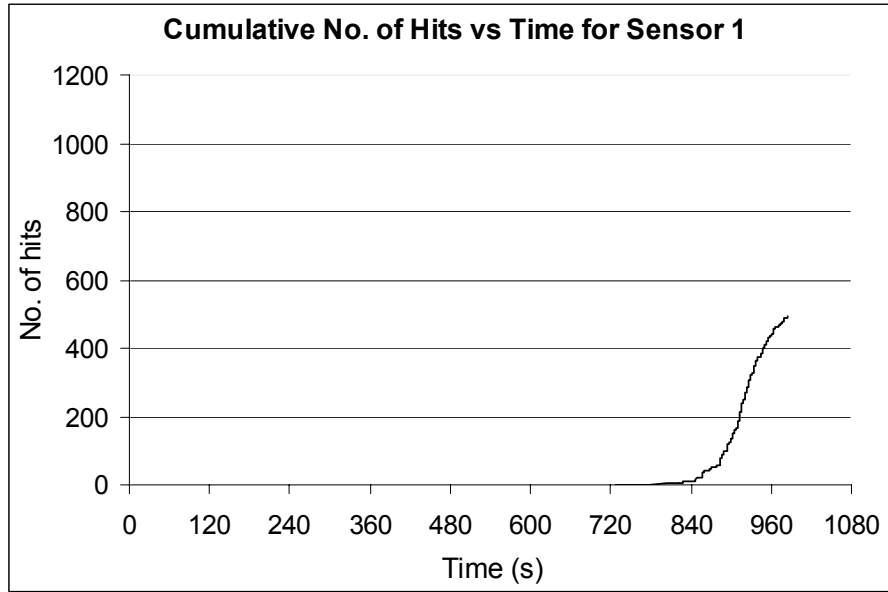
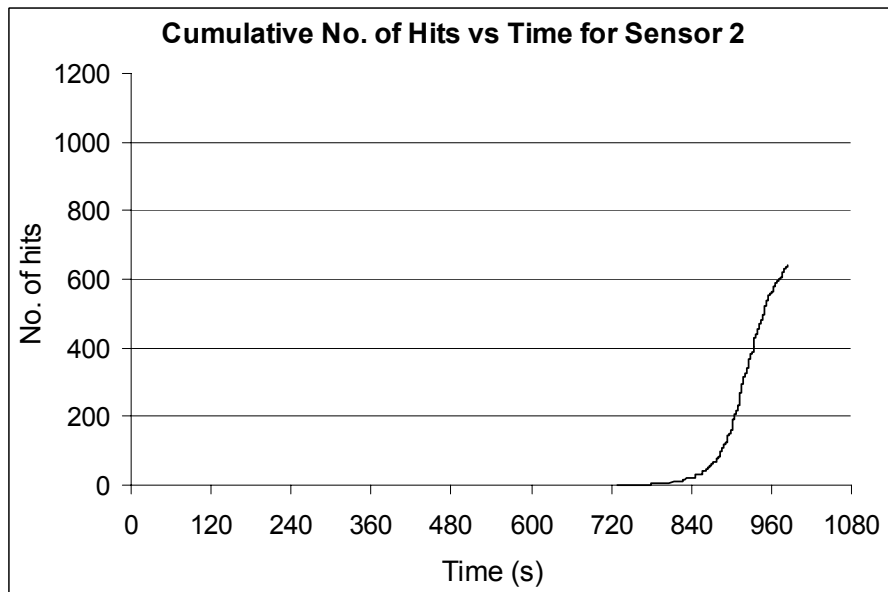
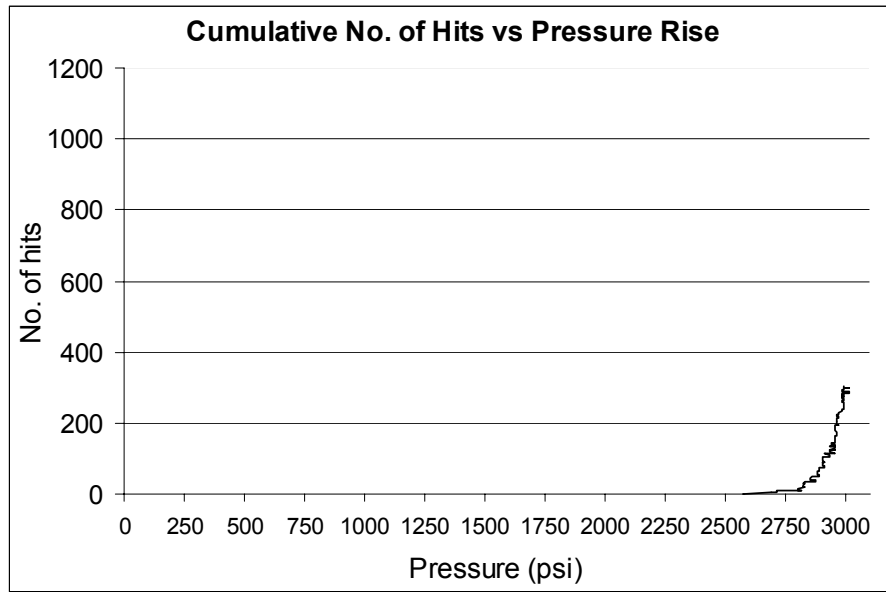
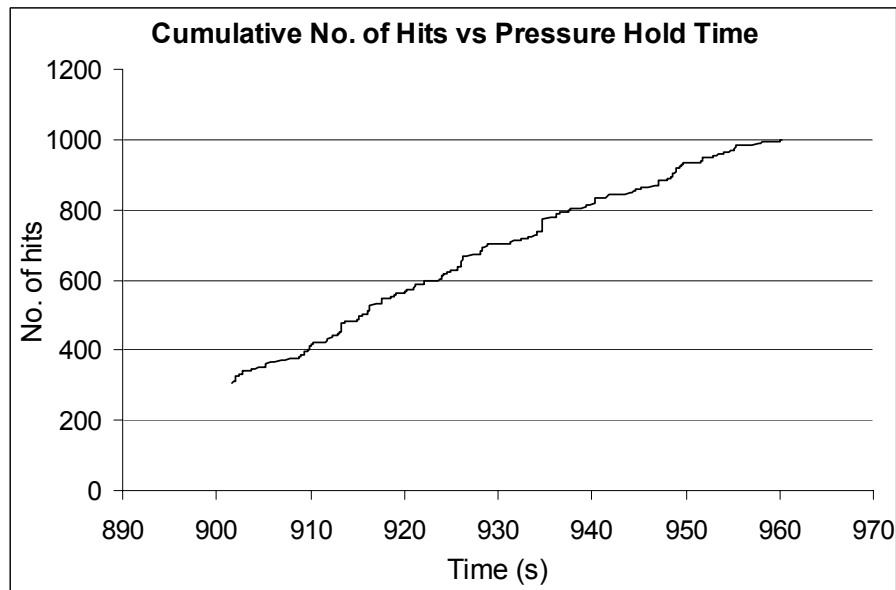
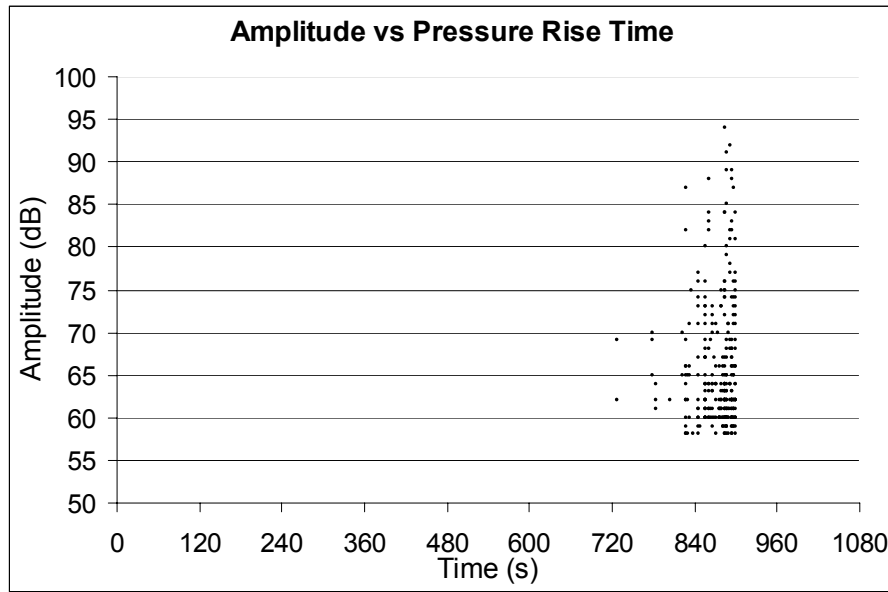
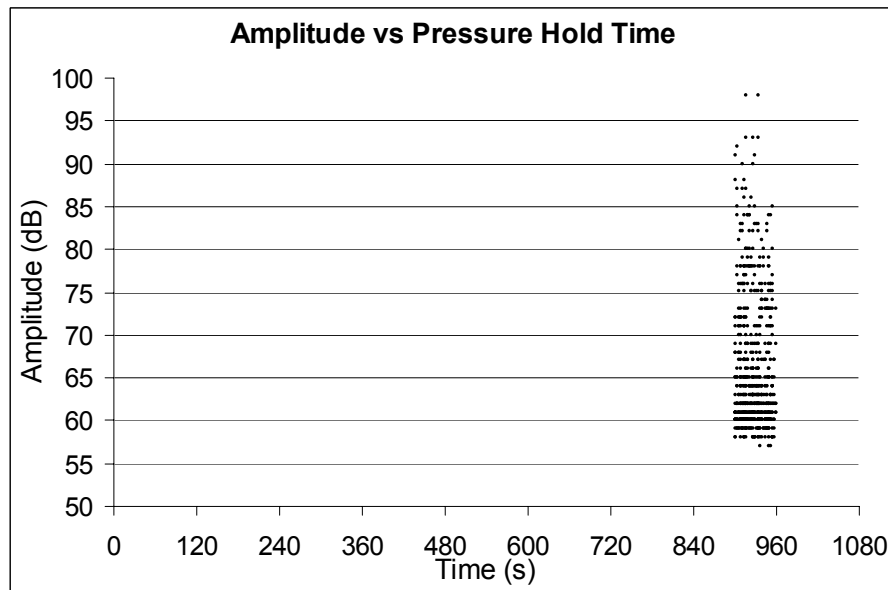
Preliminary Inspection

The test results are normal. We have almost no events under 193 bar (2800 psi), and the felicity ratio is 0.89, which is still good. Though we notice some events of high amplitude, the cylinder appears to be undamaged.

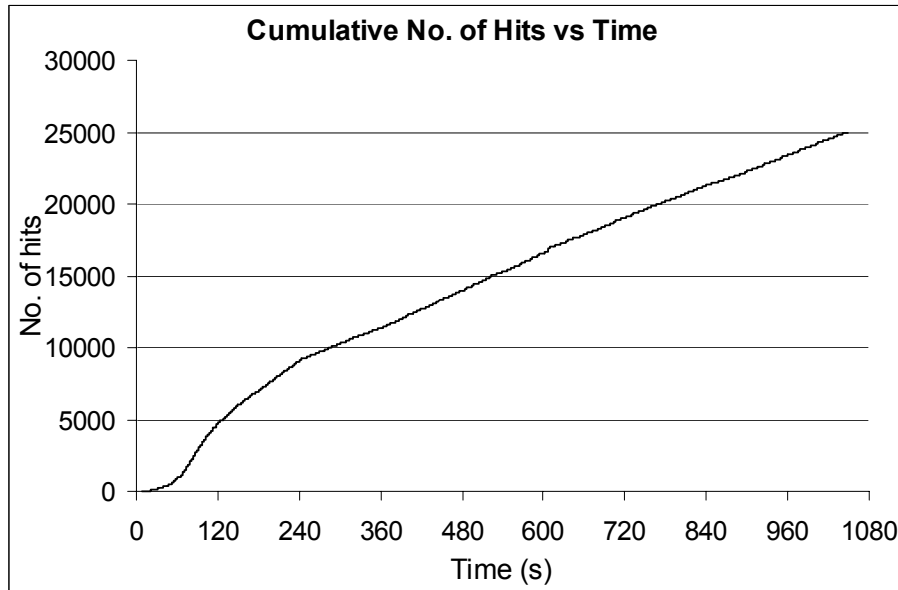
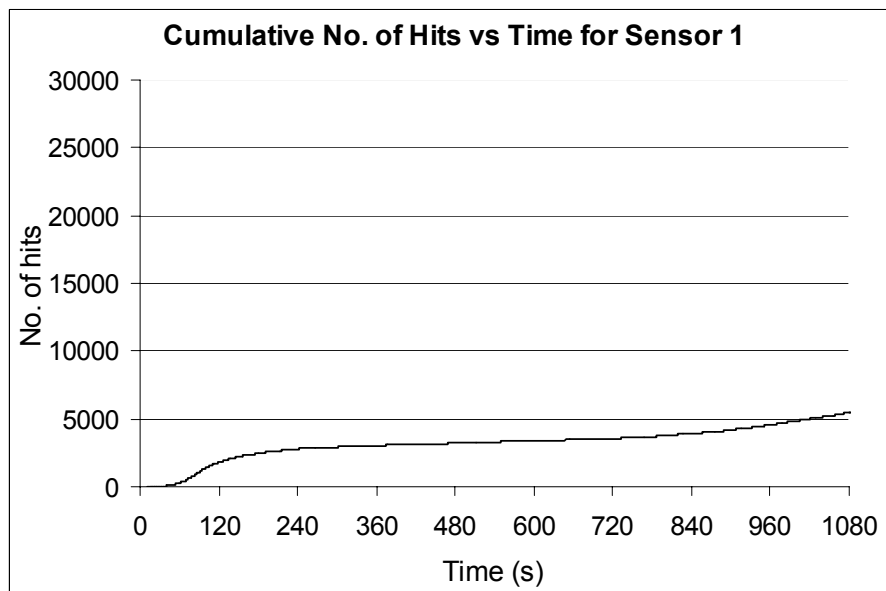
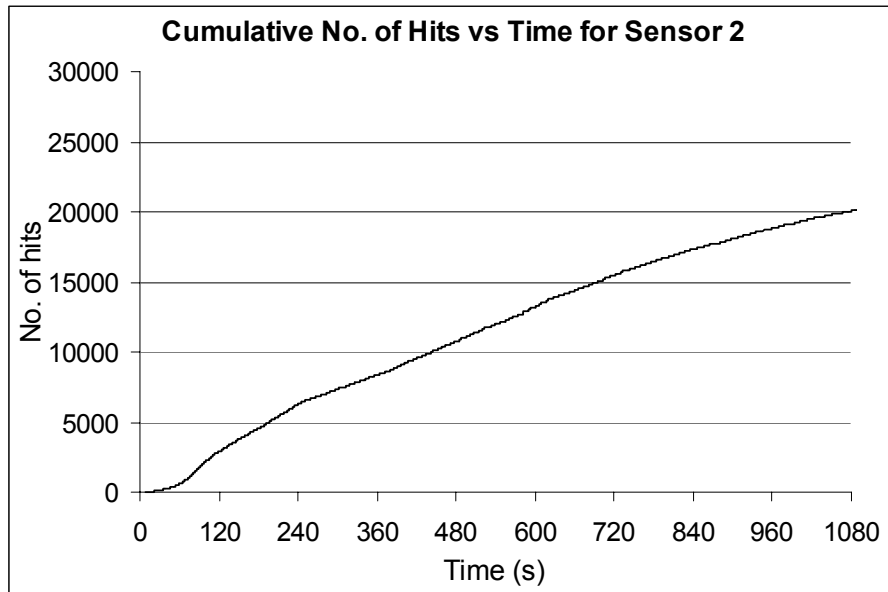
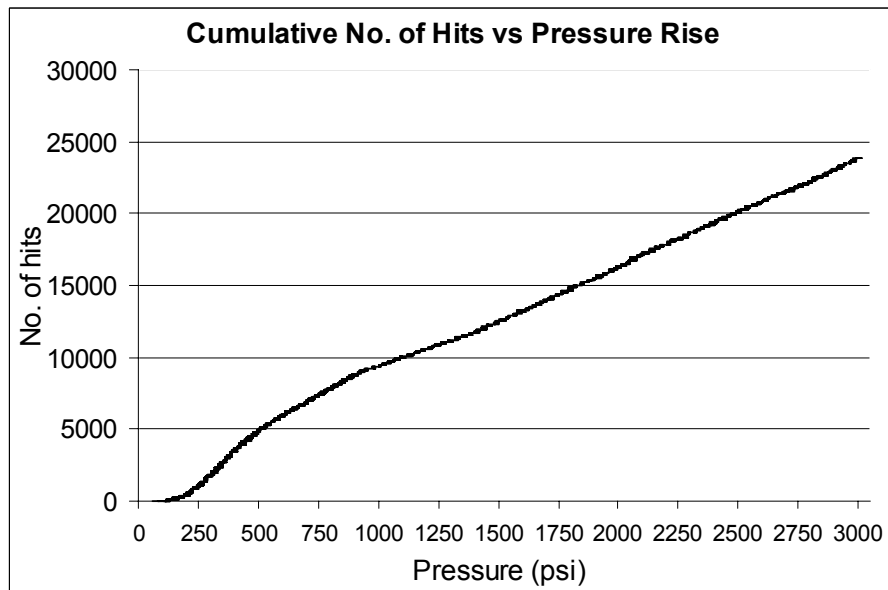
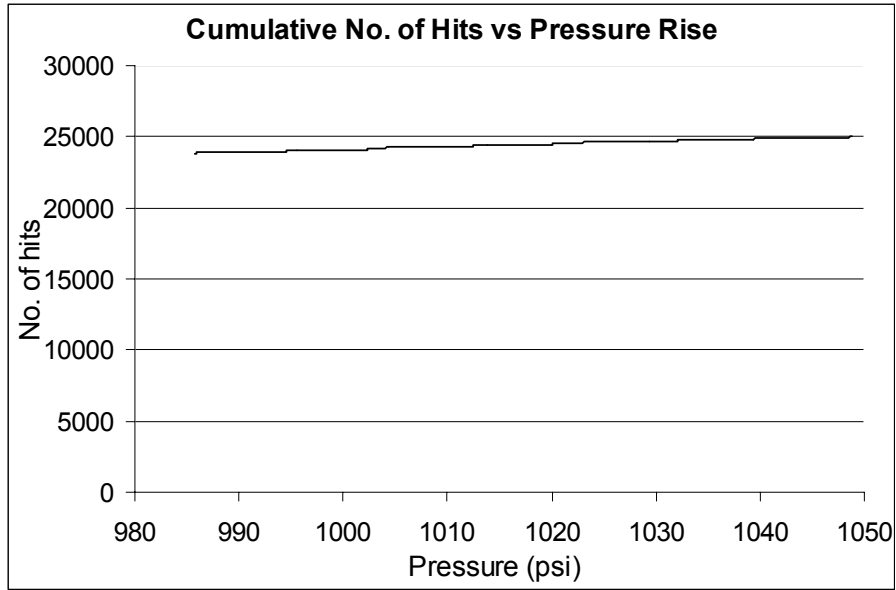
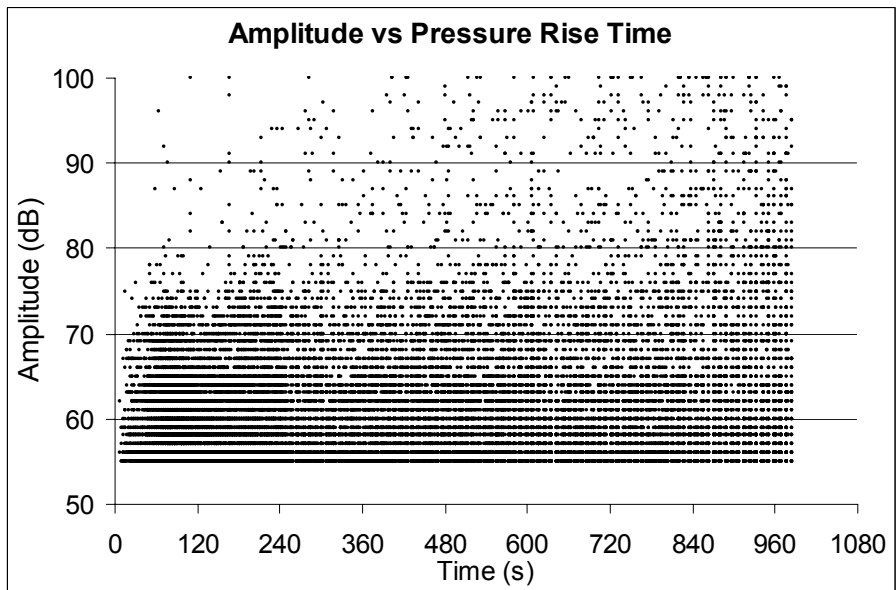
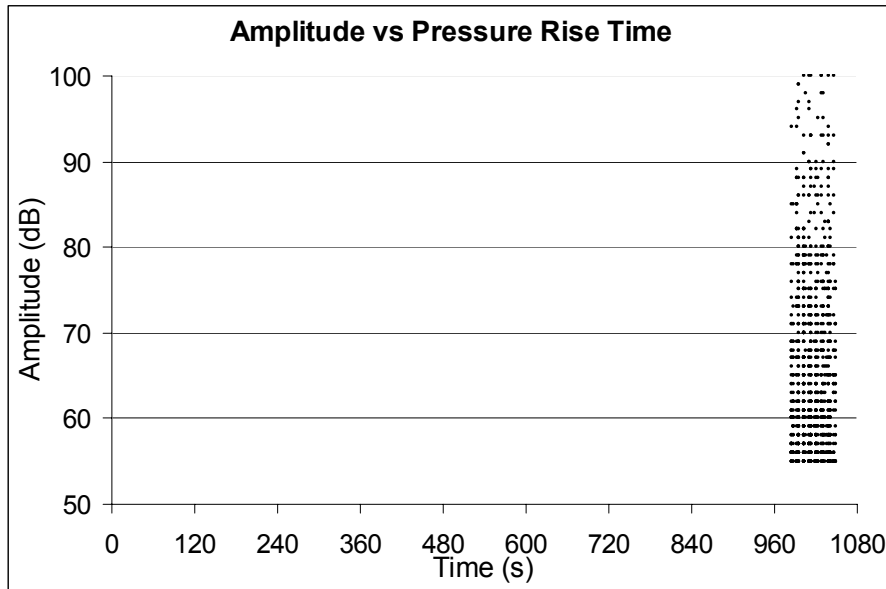
- **First Inspection**

The results are quite characteristic of a damaged cylinder, with rubbing noise at the beginning, a high number of events, and no slow down during the minute at constant pressure. The acoustic emissions start at very low pressure, as can be seen on graph 94. The felicity ratio is 0.05. We can notice a very high number of hits which amplitude is over 90 dB.
